Manhole Inspection Summary

Manhole # S27K__018MH

Insp Date: **6/16/08 7:56 AM**

Location Address: **1101 James st**

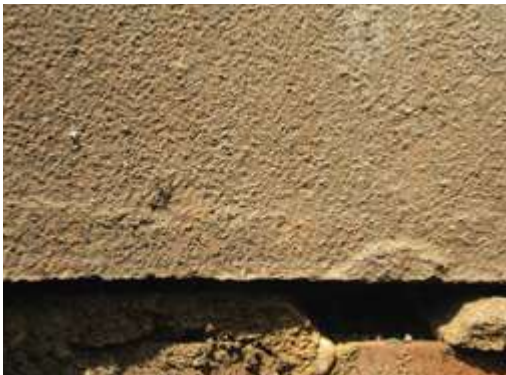
Misc

chimney gap at frame joint

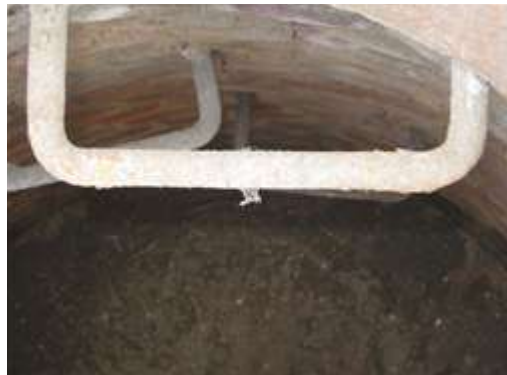
Misc

steps

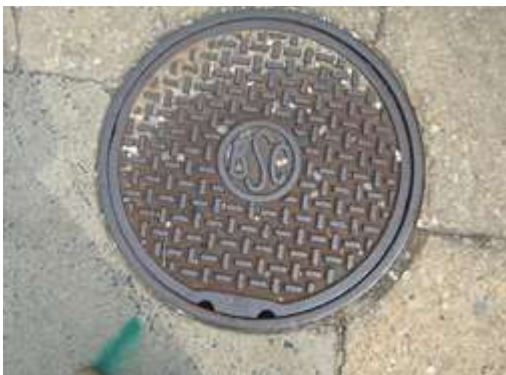
Misc

cover

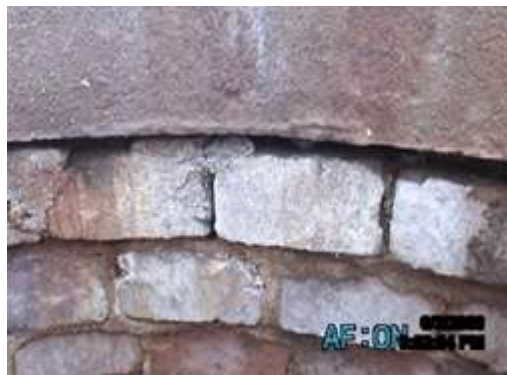
Defect 1

Condition: ☐ Sound ☐ Cracked ☐ Root Intrusion ☐ Loose Brick ☒ **Deteriorated**

Infiltration: ☐ None ☐ Joint ☐ Cracks ☒ **Mortar** ☐ Roots ☐ Wall

chimney deteriorated, chimney influent at mortar

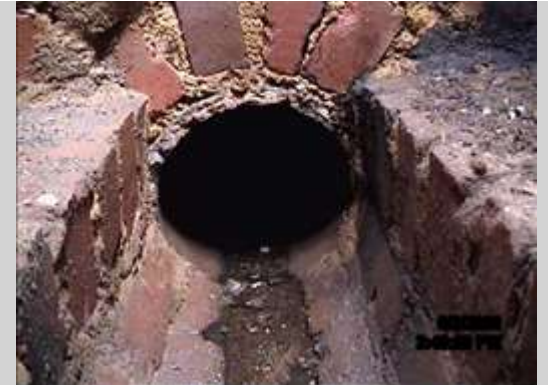
12 O'Clock Outflow

8 in. Circular Gravity Sewer
Pipe Out @ 12 O'Clock

Pipe Height: **8.4** (in.) Rod and Bar (Angled)
Pipe Material: **Clay** ☐ Pipe Lined
Invert Depth: **6.29** (ft.) Flow Characteristics: **Slow**
Deposits: ☒ None ☐ Mud ☐ Sludge ☐ Debris ☐ Grease
Silt Depth: **0** (in.) Deposits Extent:
Infiltration: **None** Pipe Seal Cond: **Sound**

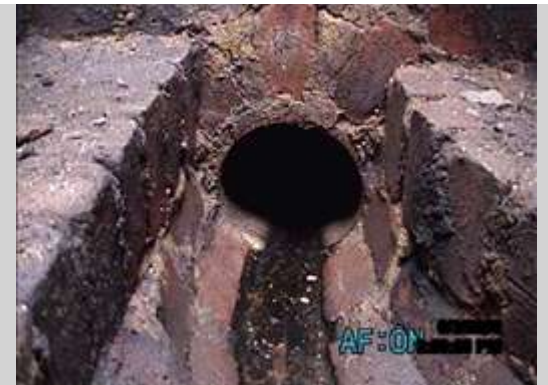
7 O'Clock Inflow

6 in. Circular Gravity Sewer
Pipe In @ 7 O'Clock

Pipe Height: **6** (in.) Rod and Bar (Angled)
Pipe Material: **Clay** ☐ Pipe Lined
Invert Depth: **6.22** (ft.) Flow Characteristics: **Slow**
Deposits: ☒ None ☐ Mud ☐ Sludge ☐ Debris ☐ Grease
Silt Depth: **0** (in.) Deposits Extent:
Infiltration: **None** Pipe Seal Cond: **Sound**
